**PROPERTY CONDITION ASSESSMENT
OF
WORLD TRADE CENTER PORTFOLIO**

FIVE WORLD TRADE CENTER

**Property #5
Merritt & Harris, Inc. Project Number 20-251E**

**Re: Due Diligence Physical Condition Survey
World Trade Center
New York, New York**

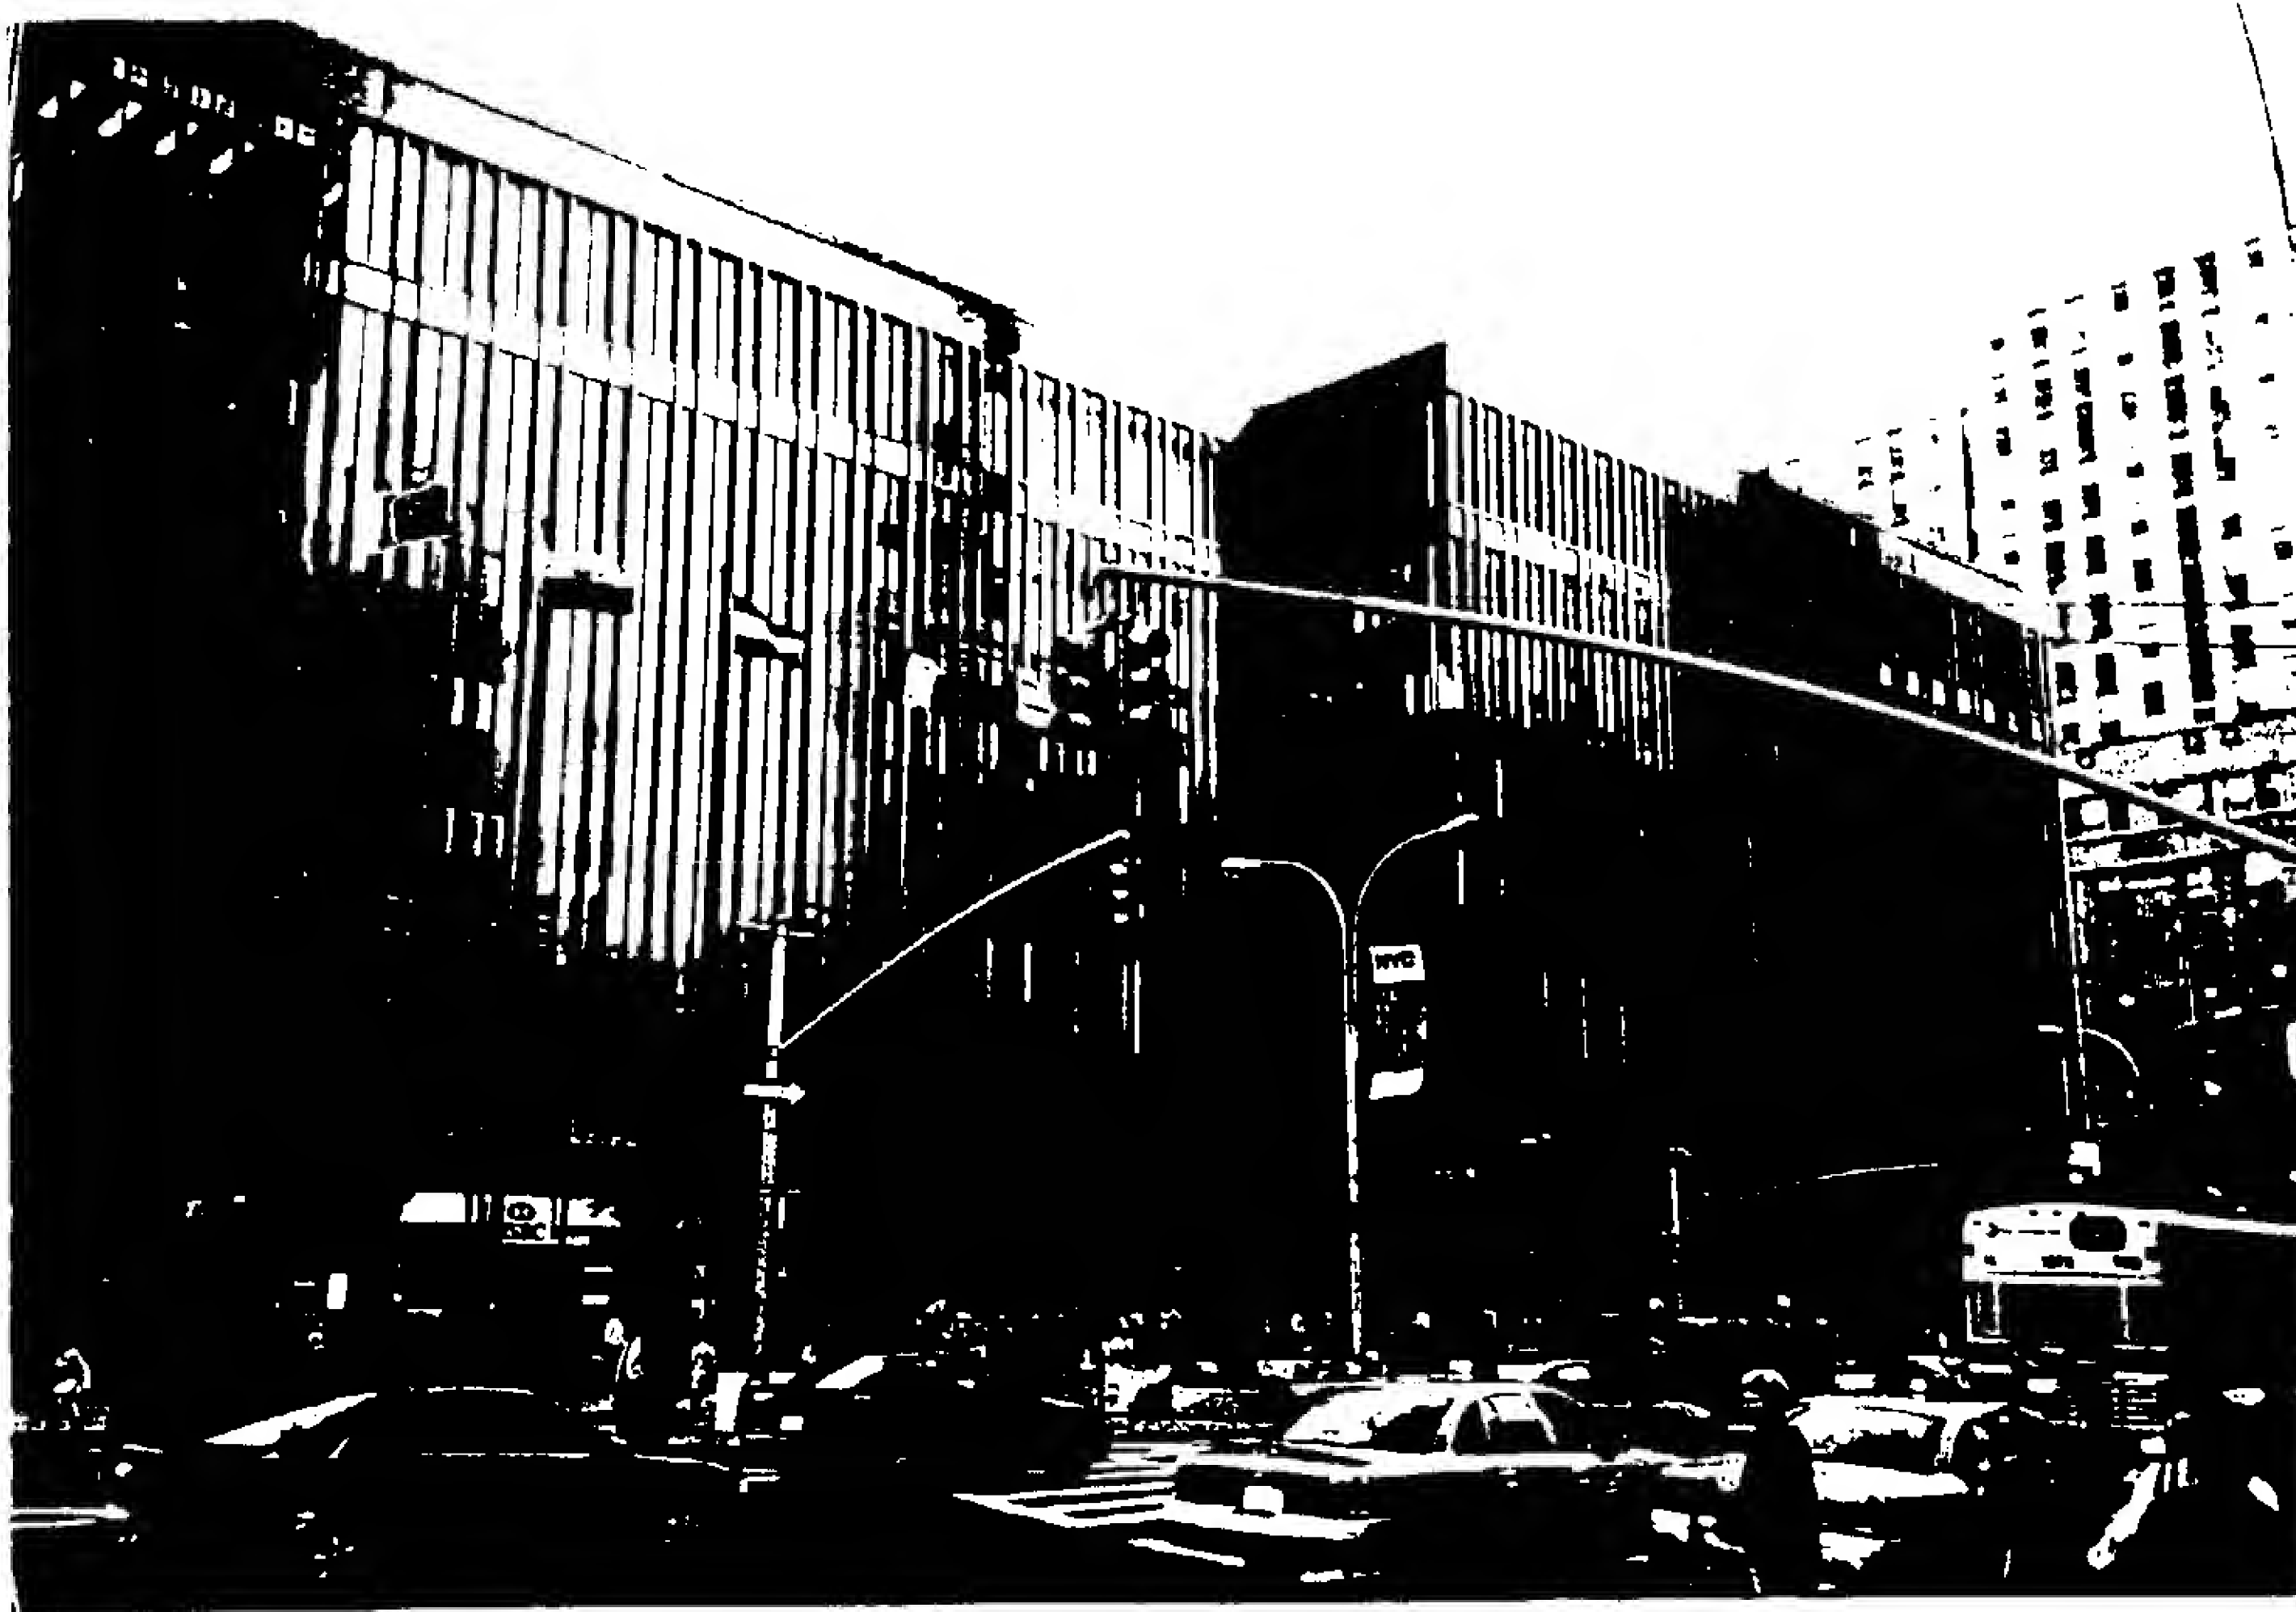
Photograph 6

Structure of B1
Level at loading
docks which also
services 4WTC
